Connecticut Building Check

Inspection Report

Property Address:
1234 Main St
Bloomfield, CT 06002

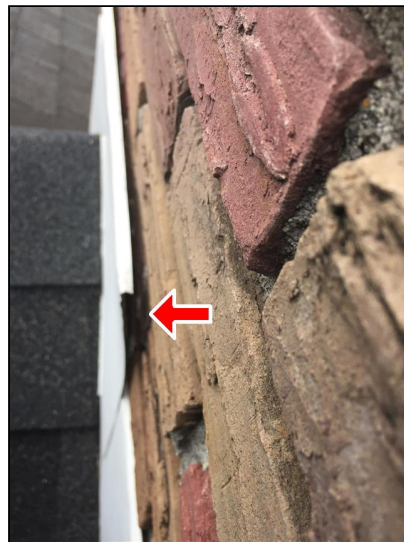
1.1 The chimney flashing is loose and requires repair to avoid moisture penetration. Allow for repair of the chimney flashing as required.

1.1 Item 1(Picture) Loose Chimney Flashing

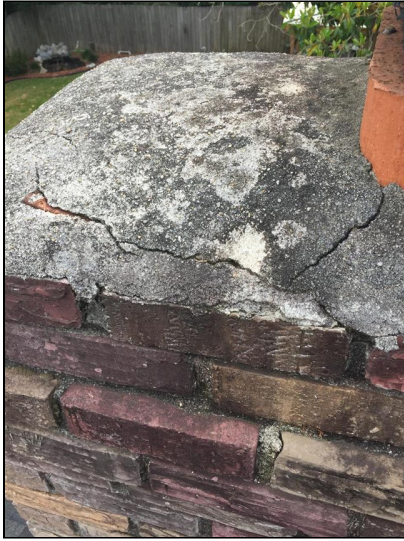
1.2 The chimney requires re-pointing (replacing mortar joints) to remain water tight. The chimney crown is cracked and requires repair. Allow for further evaluation of the chimney and chimney flues by a licensed qualified contractor for repair options and costs.

1.2 Item 1(Picture) Cracked Chimney Crown

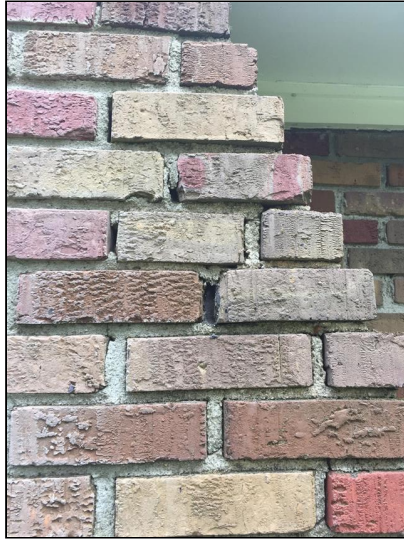
1.2 Item 2(Picture) Missing Mortar Joints

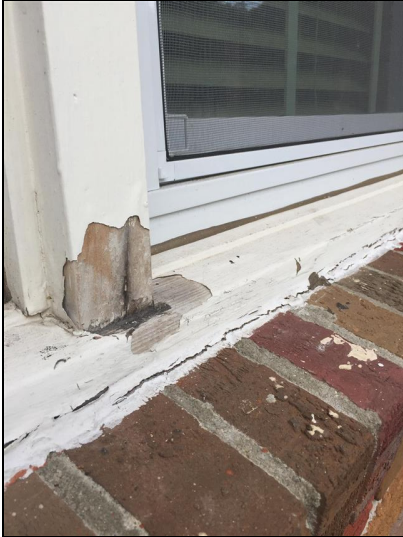
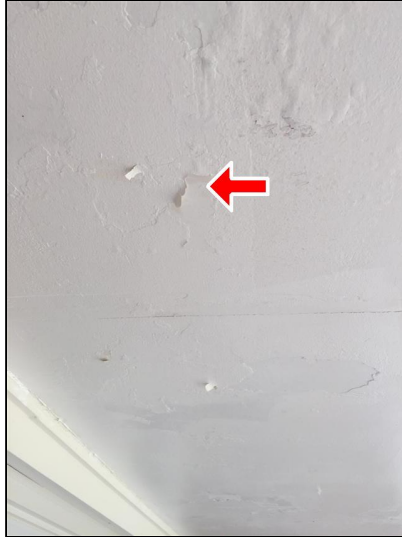
2.0 Peeling paint was observed at the exterior at several areas including the window sills and the porch overhang. Allow for exterior painting as required.

2.0 Item 1(Picture) Peeling Paint

2.0 Item 2(Picture) Peeling Paint

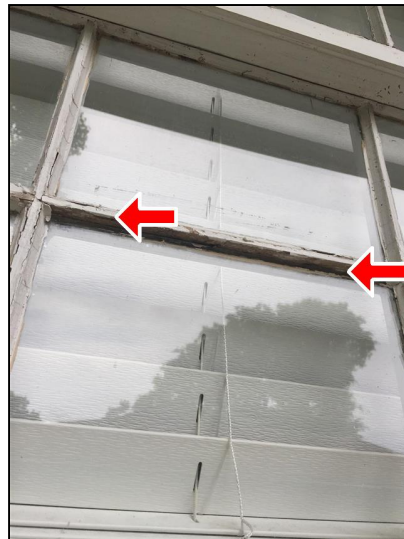
2.2 The old windows are in poor condition. Glazing improvements and painting is recommended. Replacement windows may be the best long term approach. Allow for repair or replacement of the old windows as needed.

2.2 Item 1(Picture) Missing Window Glazing

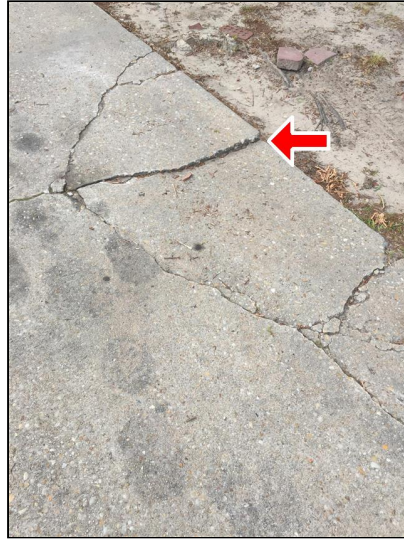
2.4 The driveway has settled to the point that it is a tripping hazard. Allow for repair to the concrete driveway as necessary.

2.4 Item 1(Picture) Driveway Settlement

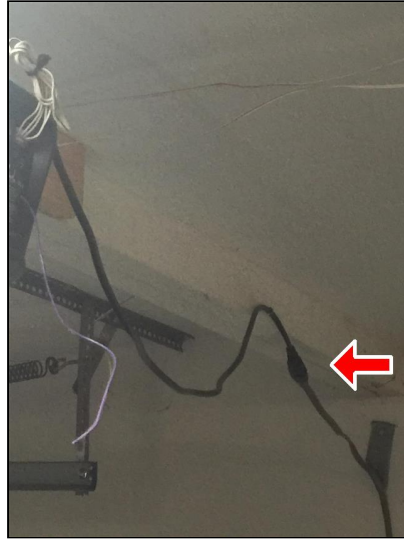
3.5 The overhead garage door openers are installed with an extension cord. Extension cords should not be used as permanent wiring. Allow for repairs as needed.

3.5 Item 1(Picture) Garage Door Opener Extension Cord

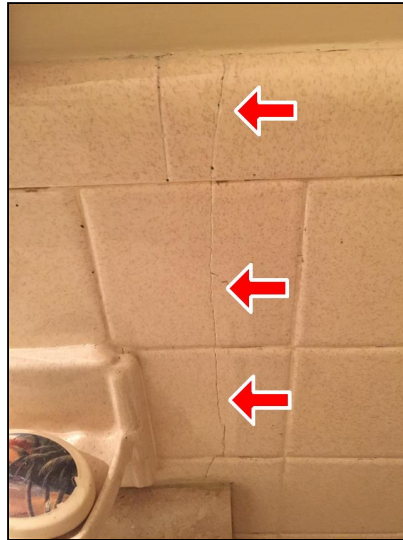
4.1 Cracked wall tile was noted at the hall bathroom. Allow for replacement of the cracked tile as needed.

4.1 Item 1(Picture) Cracked Tile

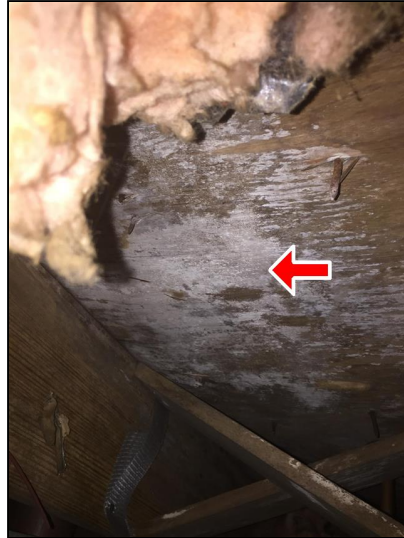
5.0 Signs of fungi growth is present on the floor system in crawlspace in several areas. We did not inspect, test or determine if this growth is or is not a health hazard. The underlying cause is moisture. I recommend you contact a mold inspector or expert for investigation or correction if needed.

5.0 Item 1(Picture) Possible Fungal Growth

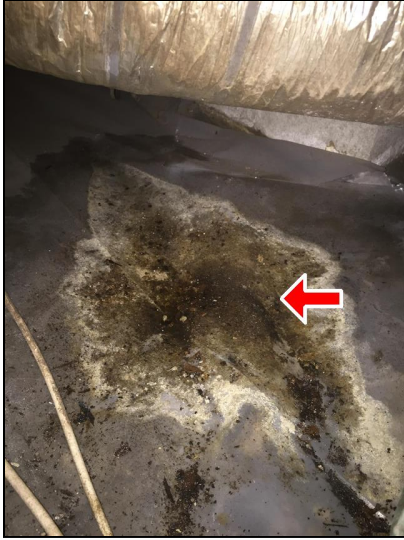
6.0 The waste piping from the hall bathroom leaks into the crawl space. Allow for repair to the waste piping by a licensed qualified plumber.

6.0 Item 1(Picture) Standing Water From Waste Pipe Leak

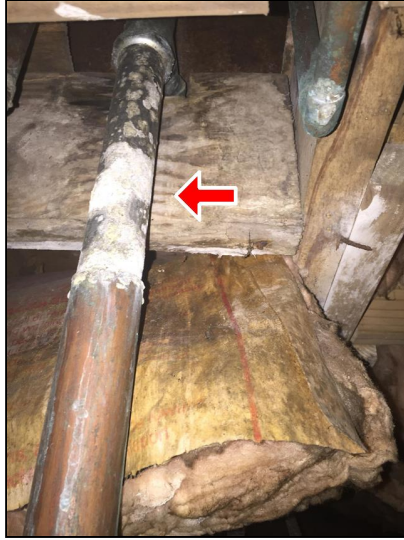
6.0 Item 2(Picture) Leaking Waste Piping

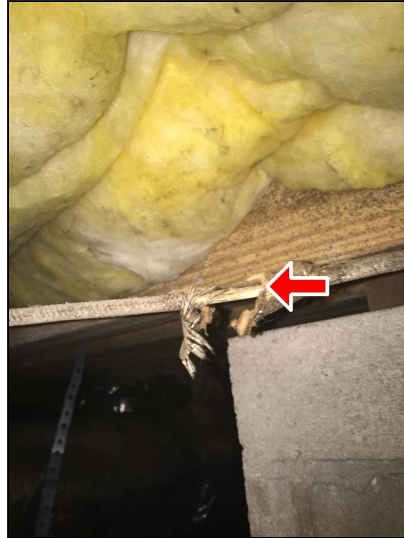
7.2 Frayed wiring was noted in the crawl space. The damaged wiring requires replacement by a licensed electrician.

7.2 Item 1(Picture) Frayed Wiring

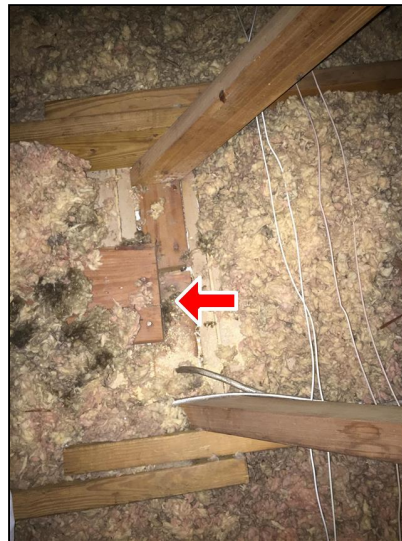
9.0 Gaps in the attic insulation should be filled for optimal performance. Allow for the addition of insulation where missing.

9.0 Item 1(Picture) Missing Insulation

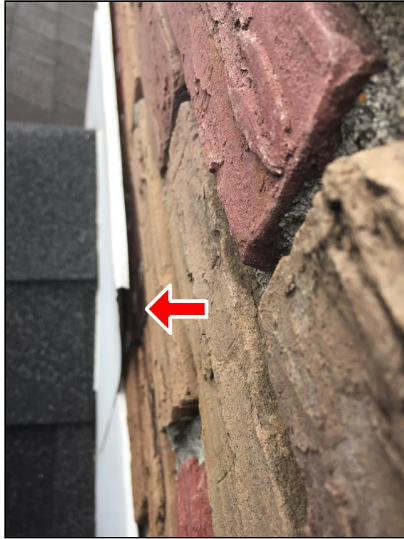
The chimney flashing is loose and requires repair to avoid moisture penetration. Allow for repair of the chimney flashing as required.

1.1 Item 1(Picture) Loose Chimney Flashing

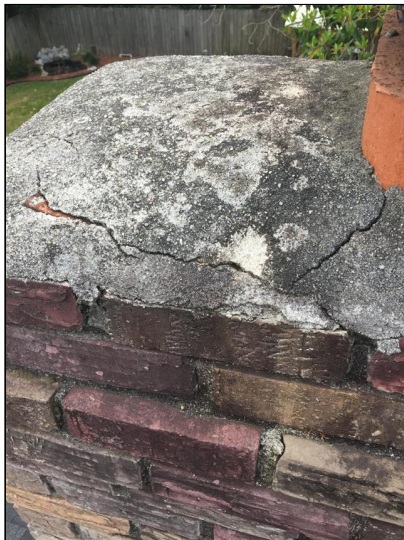
The chimney requires re-pointing (replacing mortar joints) to remain water tight. The chimney crown is cracked and requires repair. Allow for further evaluation of the chimney and chimney flues by a licensed qualified contractor for repair options and costs.

1.2 Item 1(Picture) Cracked Chimney Crown

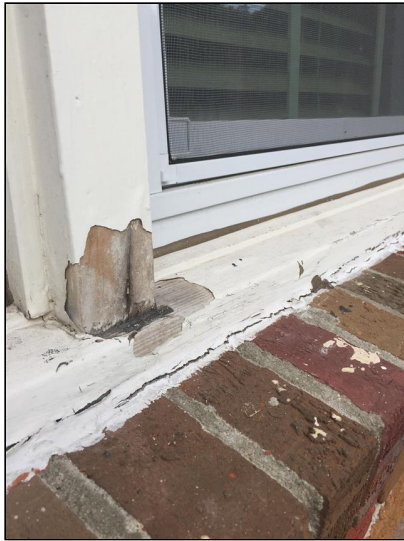
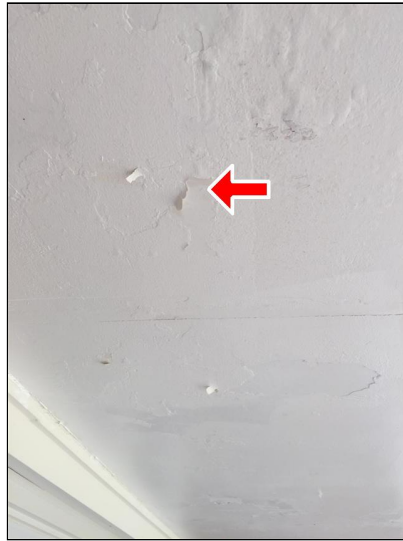
Peeling paint was observed at the exterior at several areas including the window sills and the porch overhang. Allow for exterior painting as required.

2.0 Item 1(Picture) Peeling Paint

2.0 Item 2(Picture) Peeling Paint

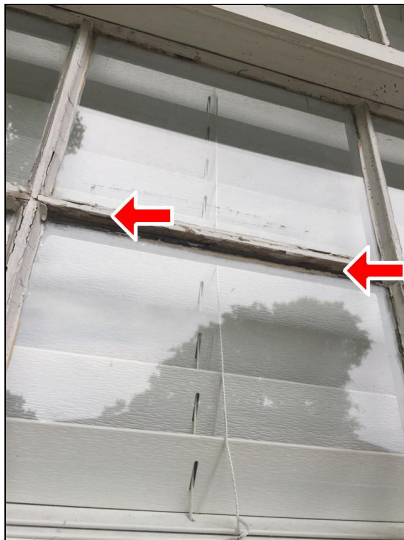
The old windows are in poor condition. Glazing improvements and painting is recommended. Replacement windows may be the best long term approach. Allow for repair or replacement of the old windows as needed.

2.2 Item 1(Picture) Missing Window Glazing

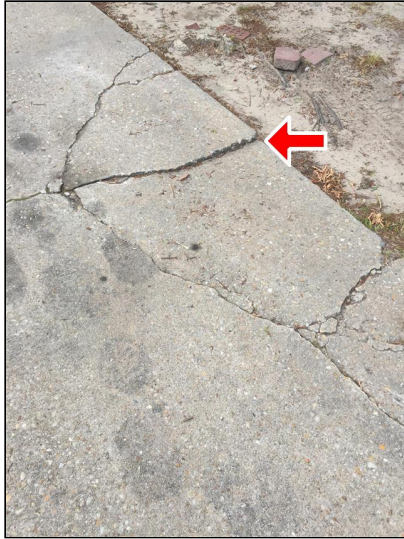
The driveway has settled to the point that it is a tripping hazard. Allow for repair to the concrete driveway as necessary.

2.4 Item 1(Picture) Driveway Settlement

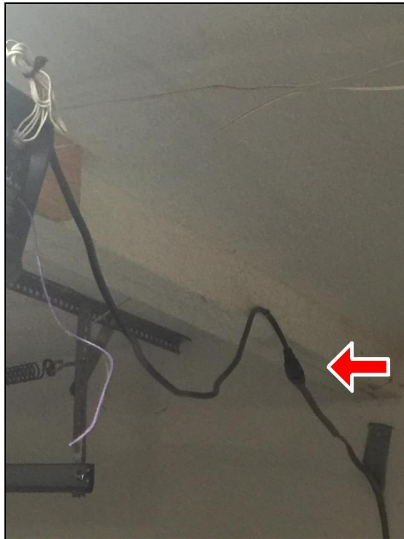
The overhead garage door openers are installed with an extension cord. Extension cords should not be used as permanent wiring. Allow for repairs as needed.

3.5 Item 1(Picture) Garage Door Opener Extension Cord

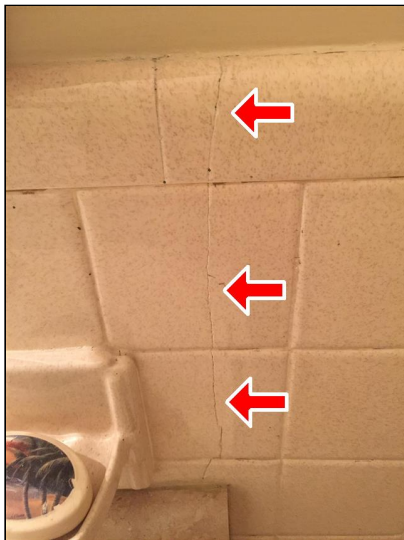
Cracked wall tile was noted at the hall bathroom. Allow for replacement of the cracked tile as needed.

4.1 Item 1(Picture) Cracked Tile

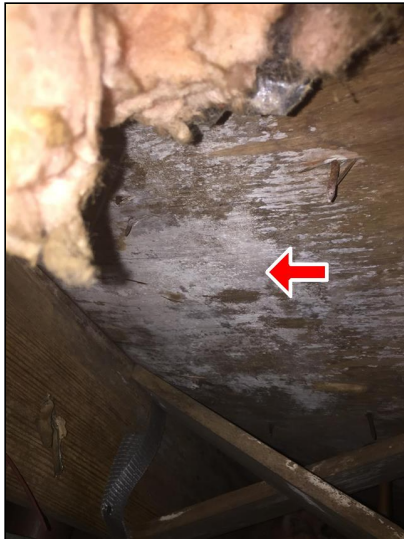
Signs of fungi growth is present on the floor system in crawlspace in several areas. We did not inspect, test or determine if this growth is or is not a health hazard. The underlying cause is moisture. I recommend you contact a mold inspector or expert for investigation or correction if needed.

5.0 Item 1(Picture) Possible Fungal Growth

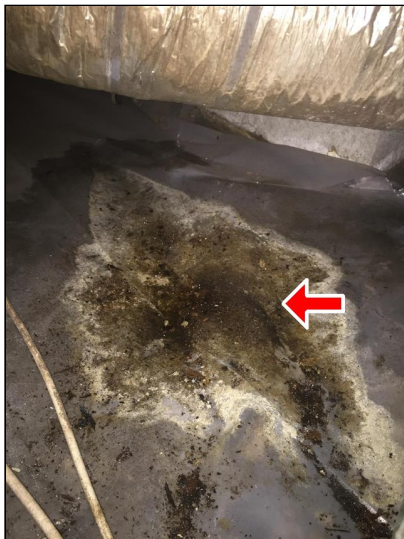
The waste piping from the hall bathroom leaks into the crawl space. Allow for repair to the waste piping by a licensed qualified plumber.

6.0 Item 1(Picture) Standing Water From Waste Pipe Leak

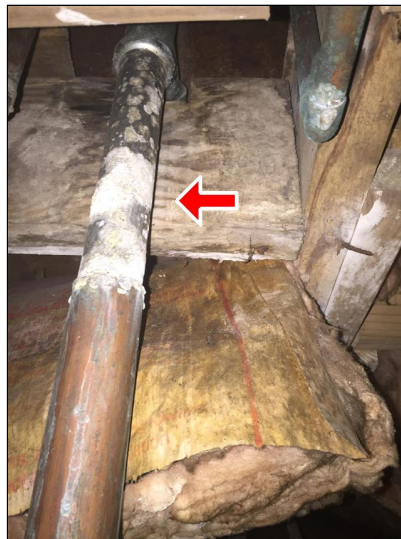
6.0 Item 2(Picture) Leaking Waste Piping

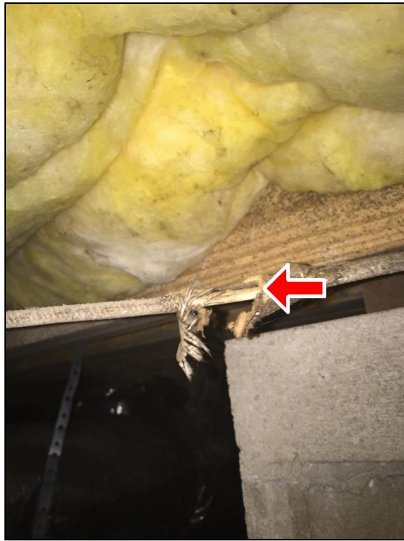
Frayed wiring was noted in the crawl space. The damaged wiring requires replacement by a licensed electrician.

7.2 Item 1(Picture) Frayed Wiring

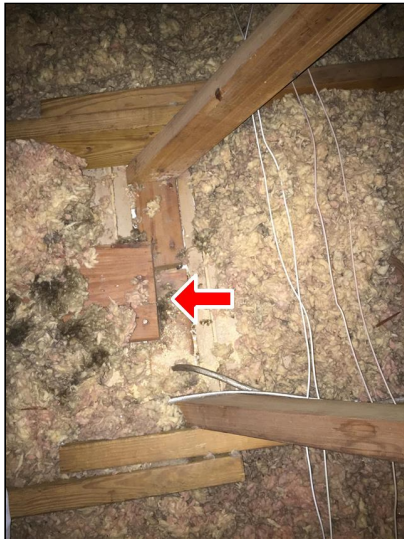
Gaps in the attic insulation should be filled for optimal performance. Allow for the addition of insulation where missing.

9.0 Item 1(Picture) Missing Insulation
